**Archaeological Evaluation at
St James's Church
Weddington, Warwickshire**

**Warwickshire**
County Council
Libraries & Heritage
Museum Field Services
Archaeology Projects Group

January 2000

Summary

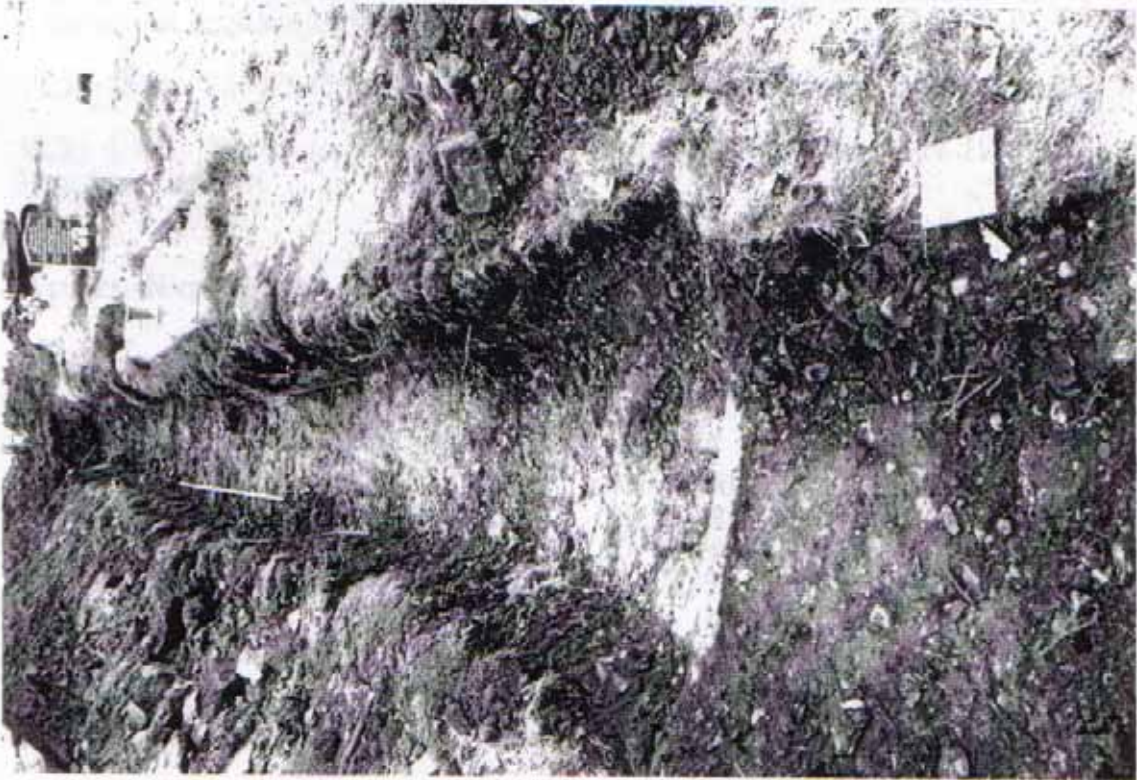
Fig. 6: Northern Trench

5.2 The northern trench measured 12.60m long by 1.10m wide and was aligned WSW-ENE (Fig. 6). The geological natural red clay, sand and gravel (9), lay at a depth of between 0.47m and 0.83m below the modern ground surface (at a maximum level of 80.16m aod).

5.3 At the eastern end of the trench, overlying the geological natural, was a spread of sandstone rubble (10) which was up to 0.38m deep and was cut (2) by the trench for a modern plastic drainpipe (3). In the remainder of the trench the geological natural was sealed by a layer of strong brown sandy loam subsoil (4), lying at the same level as the rubble. The rubble, subsoil and drainpipe were sealed by modern topsoil (1)

6.2 The area evaluated contained modern services and a spread of rubble. It is possible that the latter is a remnant of building demolition rubble from the earlier

church; the Rev. Tony Adams reported that such areas of rubble are located all over the graveyard.
